**NF P01-013 Testing Report**

Report Number KNFP010132103  
Revision Number -

**Name and definition of the sample** : KE 115 -Railing

**Procedure** : NF P01-013:1998-08 Railings tests - Determination Of The  
Mechanical Strength Under Distributed Static Loads and  
Determination Of The Mechanical Strength Under Dynamic Loads

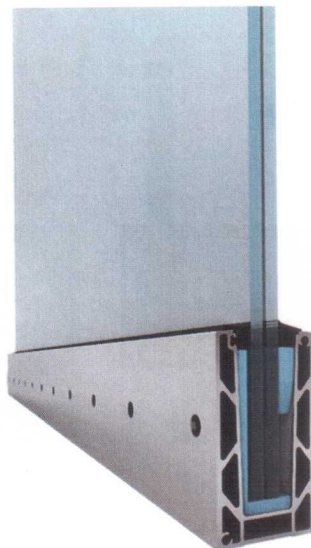
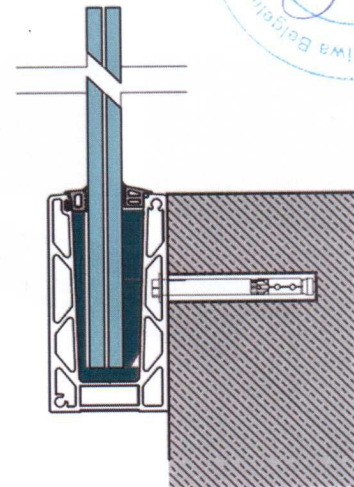
### Sample schematic drawing of the product

The railing system consists of the parts listed below.

Total length: 1000mm

Height: 1200mm

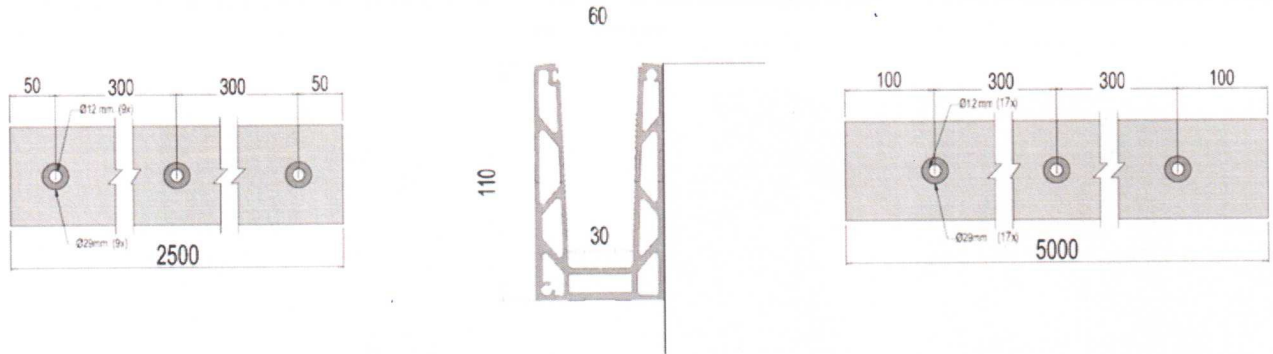
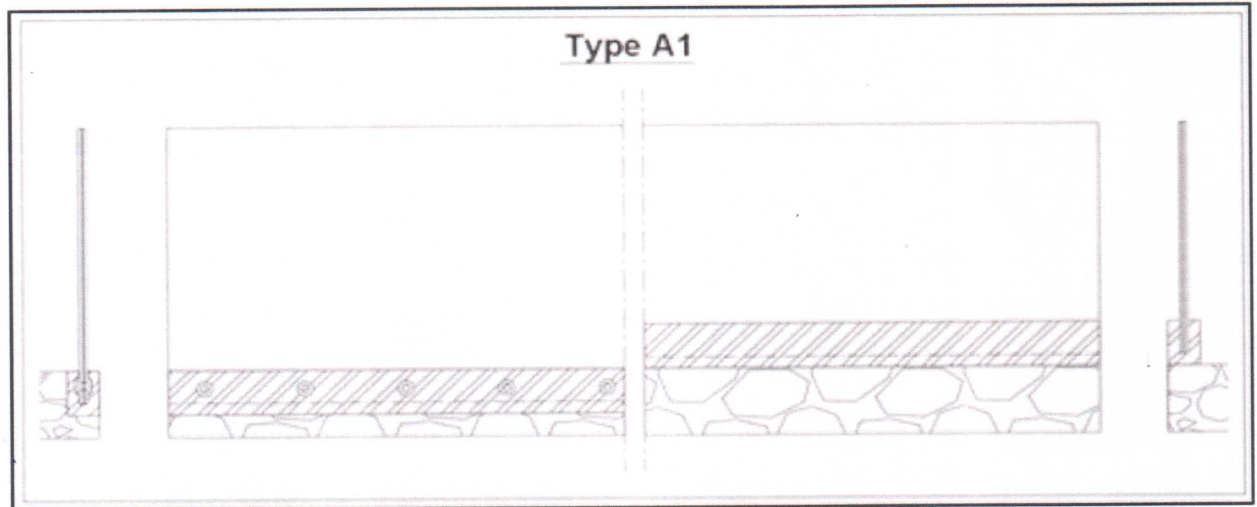
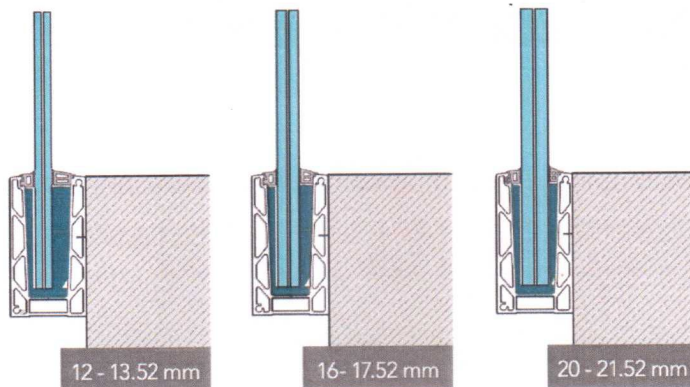
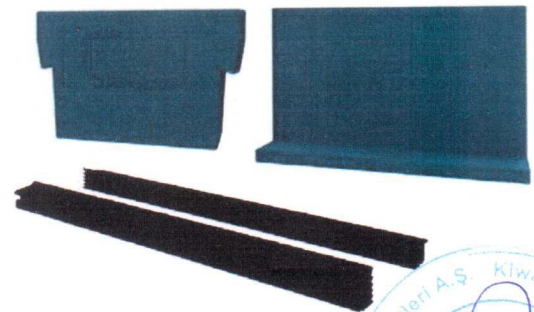
KE 115 Balustrade profile were tested for three glass thicknesses (13.52mm, 17.52mm and 21.52mm)

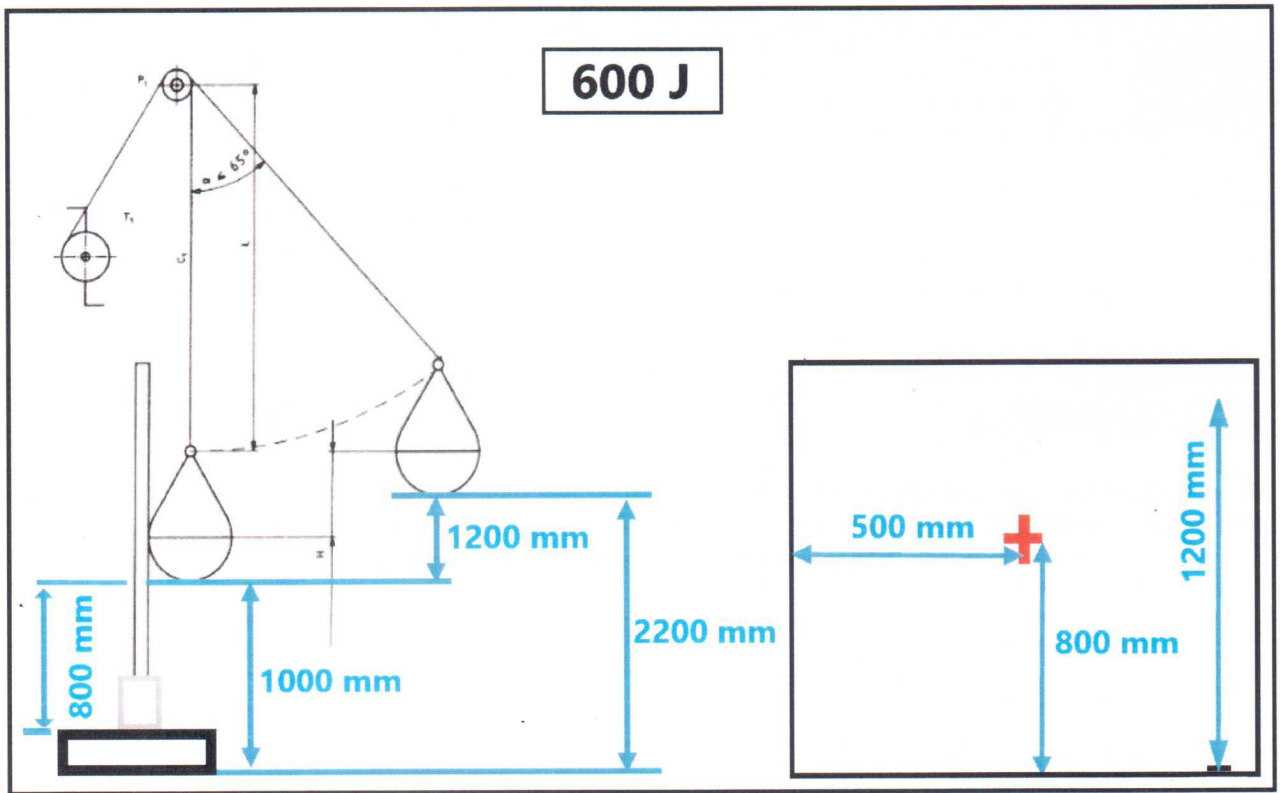
The product was released from the height of 1200 mm, with a diameter of 40 cm and a weight of 50 kg, filled with glass balls with a diameter of 3 mm, and the resulting changes in the resultant impact were observed.

| Impact area | Drop height | Glass thickness(mm) | Energy | Deformation amount of glass(mm) | Result (1) | |
|---|---|---|---|---|---|---|
| Midpoint | 1200mm | 21,52 | 600J | 60 | 4 | Compliant |
| | 1200mm | 17,52 | 600J | 70 | 4 | Compliant |
| | 1200mm | 13,52 | 600J | 75 | 4 | Compliant |
